River Red Gum dieback investigation, Malcolm Creek, Craigieburn

Clifton C¹, Treadwell, S², van den Hove R³

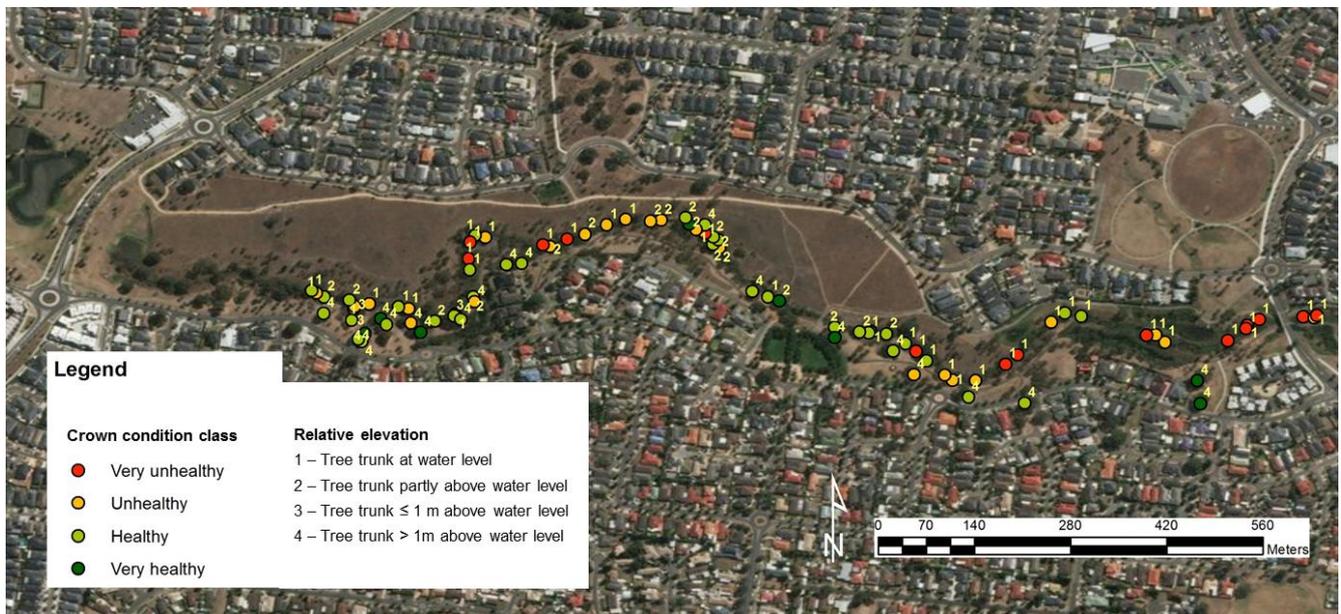
Fourteen trees were included in the poorest crown health class (I), including the five dead trees (Figure 1). All of the dead and very unhealthy trees were located within the channel of Malcolm Creek (relative elevation class 1). Two thirds of the unhealthy (class II) trees also had this same level of exposure to flows along Malcolm Creek. The RRG trees located away from the creek were mostly in healthy or very healthy condition (Table 2; Figure 1).

Figure 1. Location of trees included in this investigation, their overall crown health and relative elevation classes (ESRI background imagery).
