# Waterways and Gully Stabilisation in Vertisol Soils: Dry Creek, Condamine Catchment, QLD

Cheetham M<sup>1</sup> and Walton R<sup>2</sup>

1. Water Technology Pty. Ltd., 93 Boundary Street, West End, 4101. Email: michael.cheetham@watertech.com.au

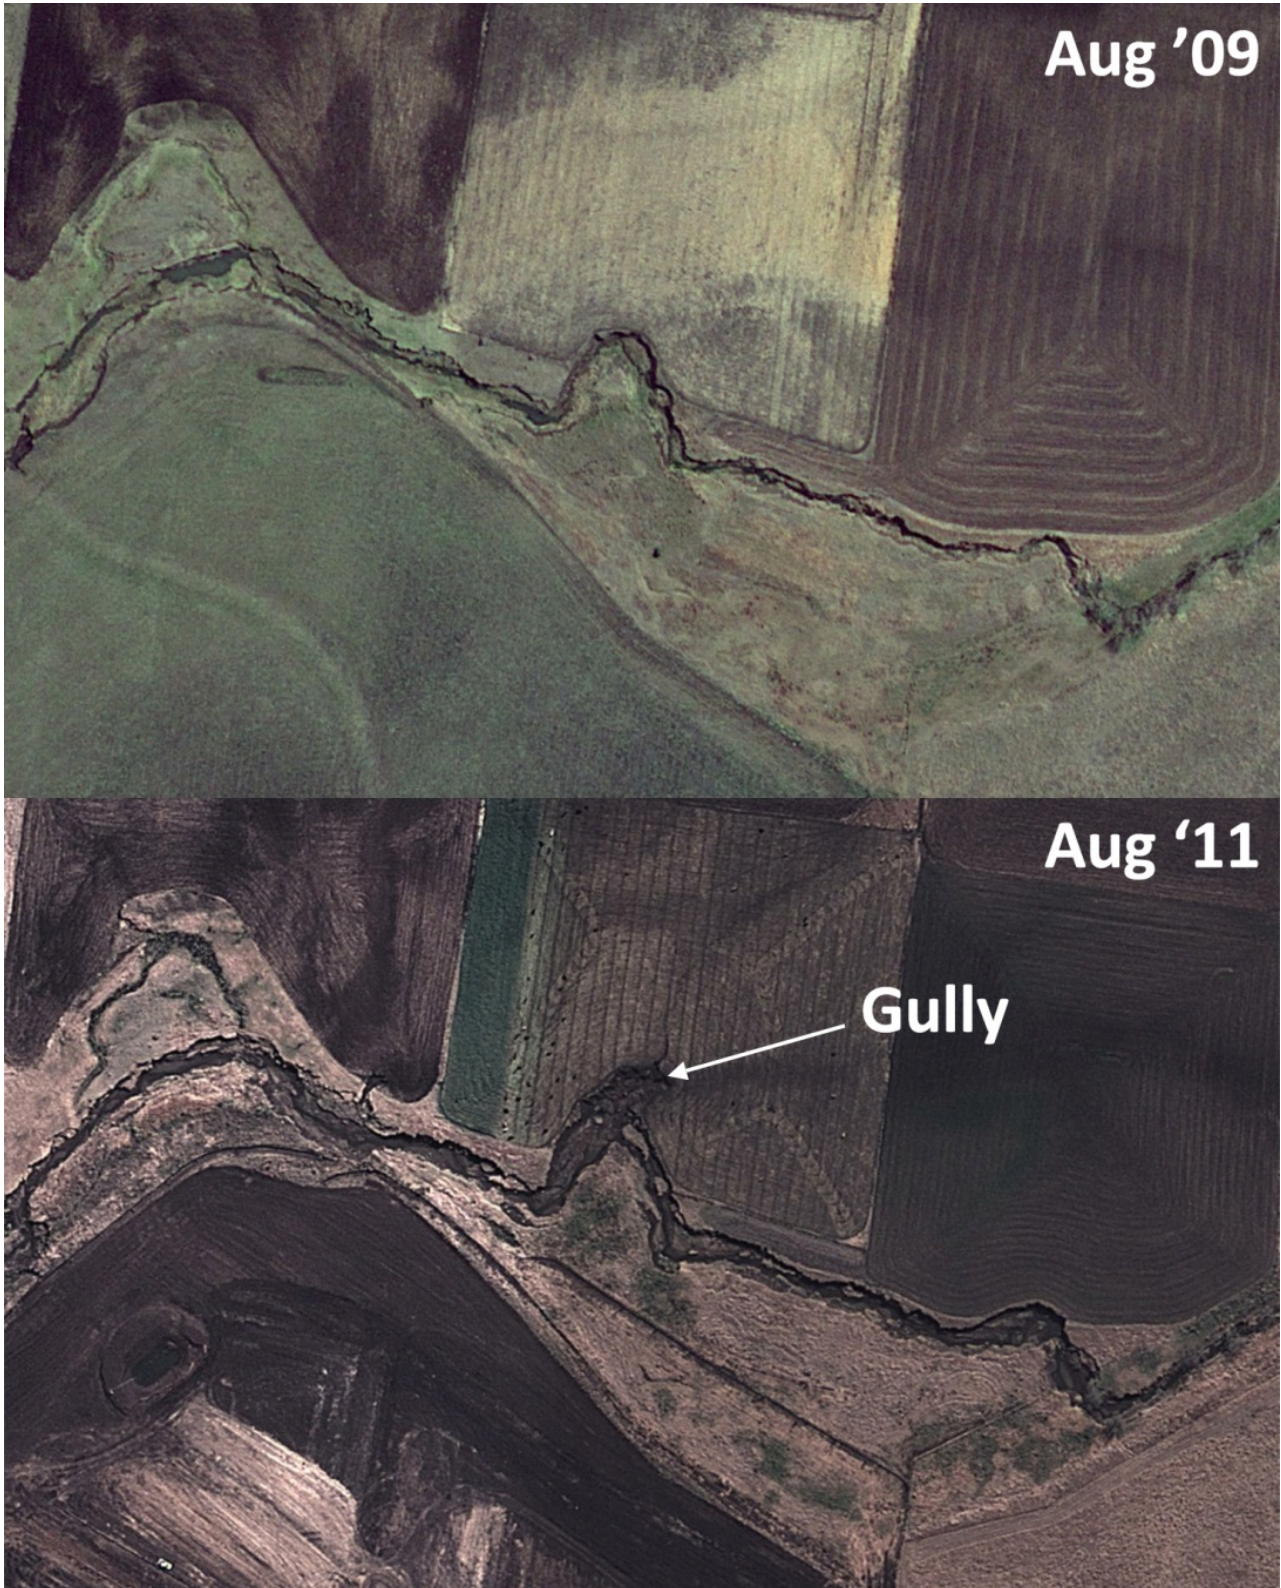
**Figure 3. Gully erosion and channel widening between 2009 and 2011 (2013 Google Earth, © 2013 DigitalGlobe).**

- Increased discharge (in response to changes in land use).
- Head-cut migration upstream (channel deepening in response to increased discharge) (Figure 1 & 2).
- Bank collapse and channel widening (in response to channel deepening) (Figure 3).
- Gully into Dry Creek floodplain at the confluence of a lateral overland flow path (also head-cut development in response to Dry Creek channel deepening) (Figure 3).
- Scour downstream of infrastructure (gabion mattresses, road crossings).

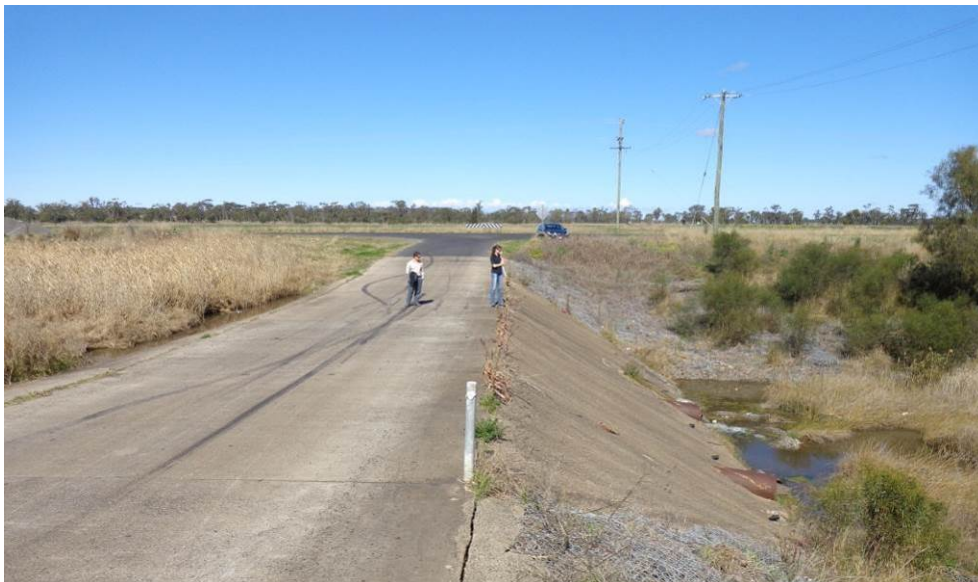
**Figure 5. Drop structure at Wallingford Road.**

Figure 5 show the drop structure located at the Wallingford Road crossing and the difference in bed elevation up and downstream of the structure. The downstream bed level is estimated at between 4 and 5 m lower than that of upstream. This highlights the degree to which incision in these soils can occur. However, incision at this location appears to have ceased, most likely due to the dramatic decrease in channel slope and thus the erosive force of the water. Widening appears to have also stopped and this reach appears to be relatively stable now although it is not known how long this structure has been in place.

Fourteen Mile Creek is a tributary of the north branch of the Condamine River. The Creek use to cross Pittsworth-Norwin Road just before it intersection with Wallingford Road but was diverted to run along the northern side of Pittsworth-Norwin Road. Like Dry Creek, Fourteen Mile Creek has experienced sever incision and widening; however, this incision is halted by a series of road crossings (weirs, drop structures etc.). Figure 5 shows the upstream and most effective structure on Fourteen Mile Creek.

Waterways in vertisol soil landscapes are highly sensitive to changes in catchment hydrology. The research conducted as part of this review suggests that once incision has occurred, there is little we can do to stop it. The effectiveness of the Wallingford Road drop structure is promising, as it suggests that there is a slope, at which incision slows significantly in these soils. That slope, however, is estimated at close to zero and this drop structure is a very large and costly in-stream grade control measure. Perhaps this will be a good deterrent for developing these landscapes. If further development of vertisol soil landscapes is to be pursued, a great deal of research is required to establish an effective methodology for stabilising waterways.
