Water quality offset investment in riparian restoration to reduce sewerage treatment costs - Part 1: determining the sediment loss avoided through riparian restoration.

O'Mara et.al. – Water quality offset investment in riparian restoration to reduce sewage treatment costs: part 1

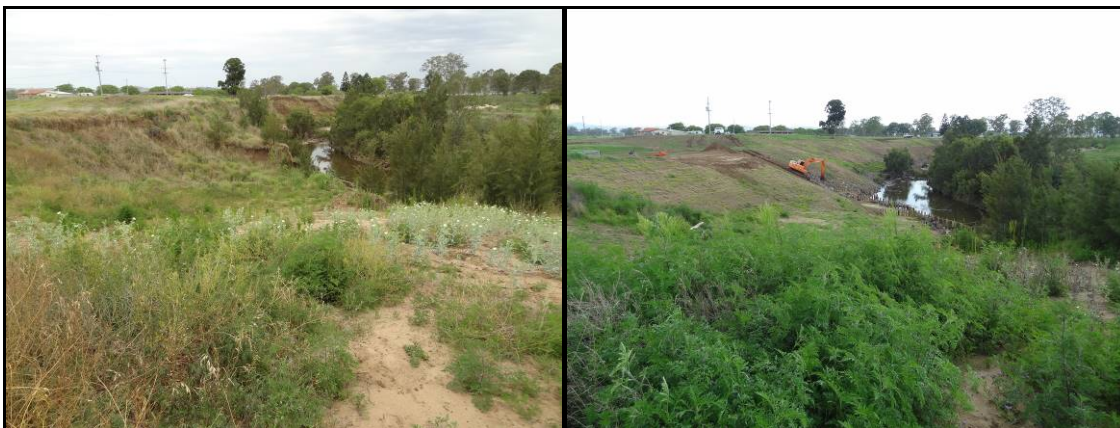
The two dominant bank erosion forces observed in South-east Queensland are fluvial scour, where stream-flow shear forces exceed bank shear resistance, and gravitational mass failure, where bank mass exceeds bank shear resistance and the bank slumps (see for example Grove et al., 2013). The longer of the two reaches selected for the pilot study experienced fluvial scour (Figure 3a), while the smaller downstream reach experienced gravitational mass failure associated with a high-flow drainage line (Figure 4a).

Figure 3: The larger Reach affected by fluvial scour – (a) prior to restoration; and (b) immediately post restoration earthworks

- Earthworks (Figure 3b) -
 - Rock revetment, rock beaching and pile fields – BSTEM has default values that were used unless experience and/or literature findings suggested an enhancement,

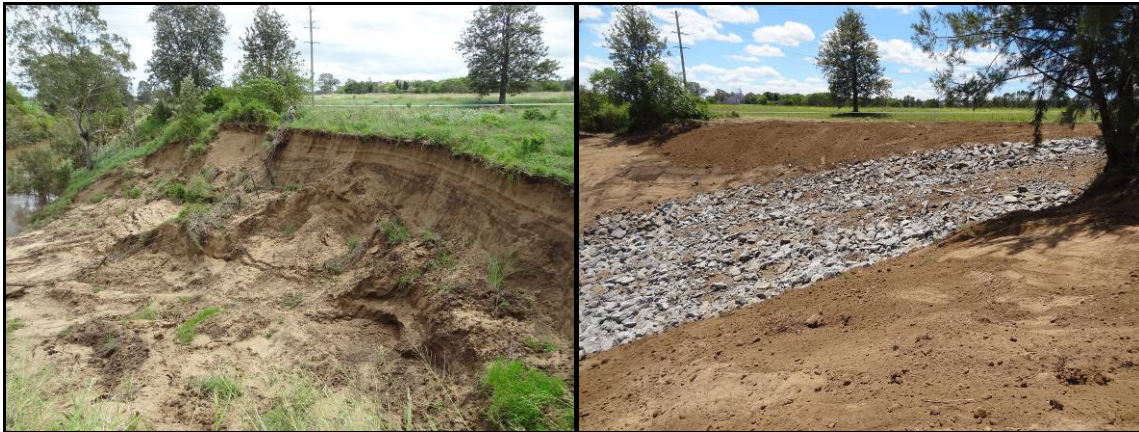
Figure 4: The larger Reach affected by fluvial scour – (a) prior to restoration; and (b) nearing completion of restoration earthworks

For the second smaller target Reach in the pilot study, no bank erosion model was identified as being able to model the high-flow, wet-flow slumping (Figure 4). However, the historical record of topographic and LiDAR data was deemed to be sufficient to estimate annual sediment loss in the un-remediated condition. An assumption was made that failure only occurred when flood flow was high enough to engage the high-flow channel. Hydraulic modelling was used to assess the flood stage needed to engage the high-flow channel. Cross-checking this height with 50 year flood records revealed that four floods over the last 50 years engaged the high-flow channel. Historical bank morphologic change was used to assess average annual loss from the unremediated bank. As restoration works at the Reach (Figure 4b) comprised total rock lining of the bank face, the restoration works were assumed to remove the bank erosion risk. Revegetation was undertaken, but was assumed not to contribute further to bank stability.

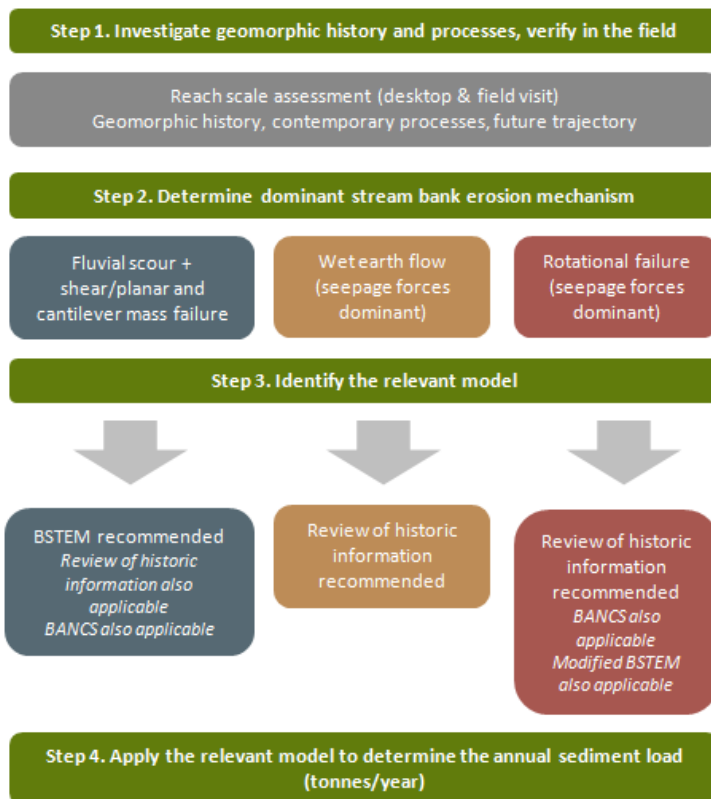
A recommended expert system for selecting an appropriate approach to modelling bank erosion was developed (Figure 5). BSTEM was considered to be best suited to modelling degraded banks subject to scour erosion, as was the case for the larger Reach in the pilot study. No model was considered to be well suited to the smaller Reach in the Pilot study, which is dominated by characteristically large bowl-shaped, high-flow, wet-flow slumping. However, as the historical records for this site were considered to be adequate, review of historical information was considered sufficient for use in estimating unremediated sediment erosion risk.

Figure 5: Expert model proposed to model bank erosion

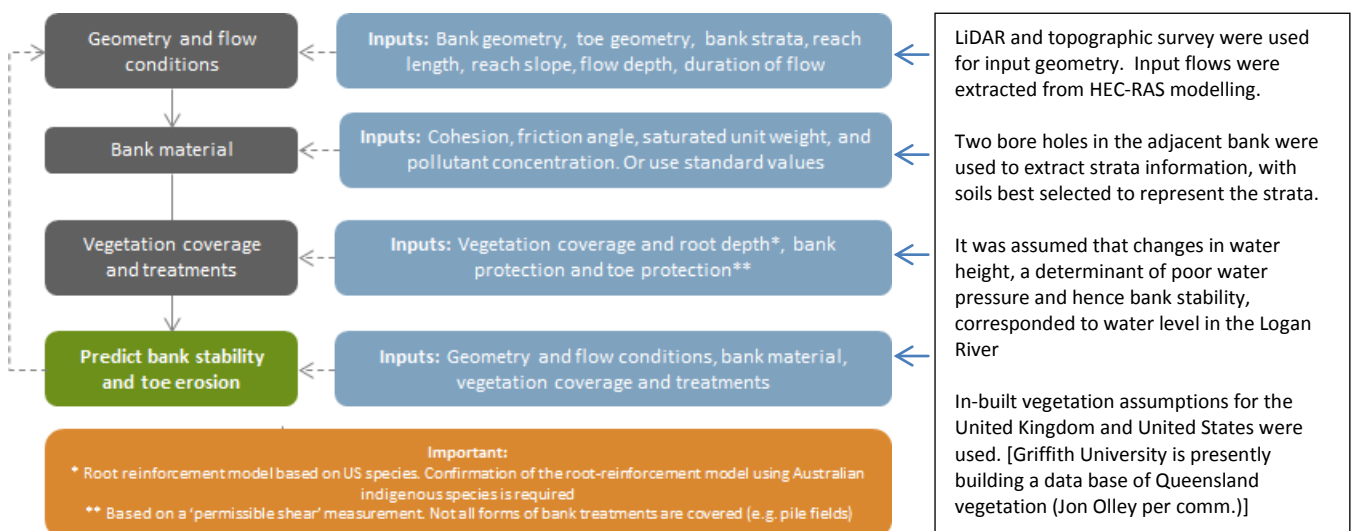
In the work reported here, BSTEM was used interactively to simulate bank stability and toe erosion over the duration of flood hydrographs. The components and inputs of BSTEM, together with notes relating to the inputs are shown schematically in Figure 6.

Figure 6: Components of BSTEM showing inputs

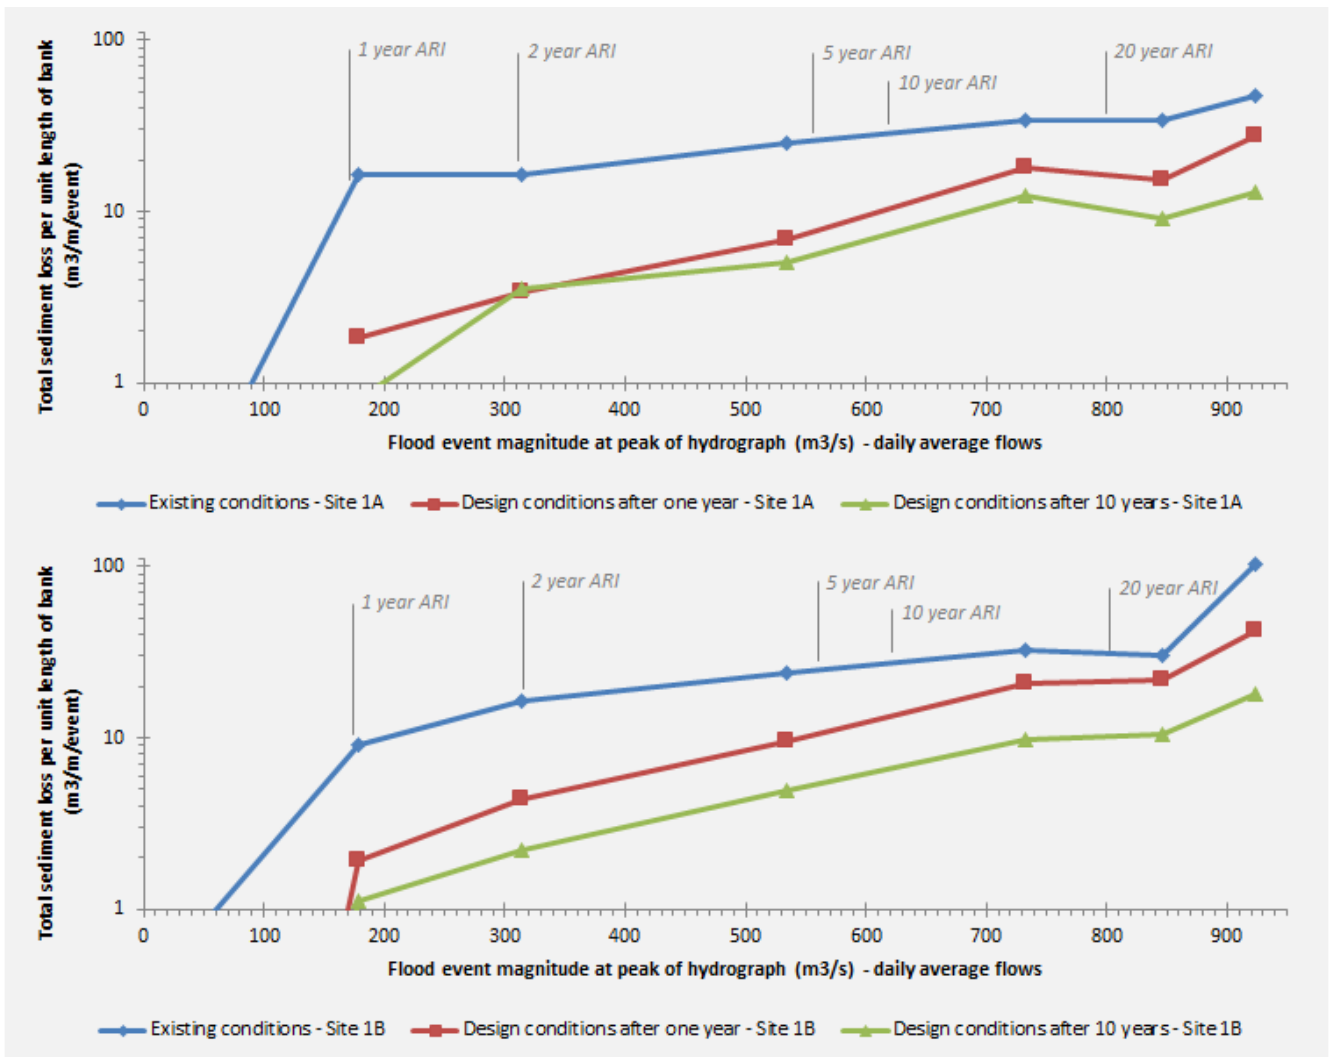
Modelled total erosion losses for design flood events at the major target site are shown in Figure 7 for the pre-remediation condition, 1 and 10 year post-remediation condition. Noting the scale on the Ordinate, the curves highlight the increasing contribution made by maturing riparian vegetation to bank stability over time. They also highlight the relatively greater contribution of high flood-flow events to bank erosion loss. However, it should be noted in this context that while not as significant in quantum, the effects of low flow toe erosion on the un-remediated site are important contributors to high flow instability.

Figure 7: Modelled BSTEM estimates of sediment erosion under non restored (blue) and post bank restoration (red= year 1 and green = year 10) at both sites of the major target Reach.

The relationship shown in Figure 7 between flood event magnitude and total event sediment load was applied to the complete flow record for the target Reach in an un-remediated condition and remediated condition. A total of 160 flood events were recorded over the 50 year record. An average annual sediment loss for the major target Reach in both the un-remediated and remediated condition was determined by summing the sediment loads for all 160 events and dividing by the 50 years of records. The average annual sediment offset, or average annual sediment avoided by river
