## **When Perception and Evidence Based Practice Collide – Floodplain and Waterway Management in the aftermath of the 2016 Floods at St Marys, Tasmania**

Skipworth J<sup>1</sup> and Buchhorn P<sup>2</sup>

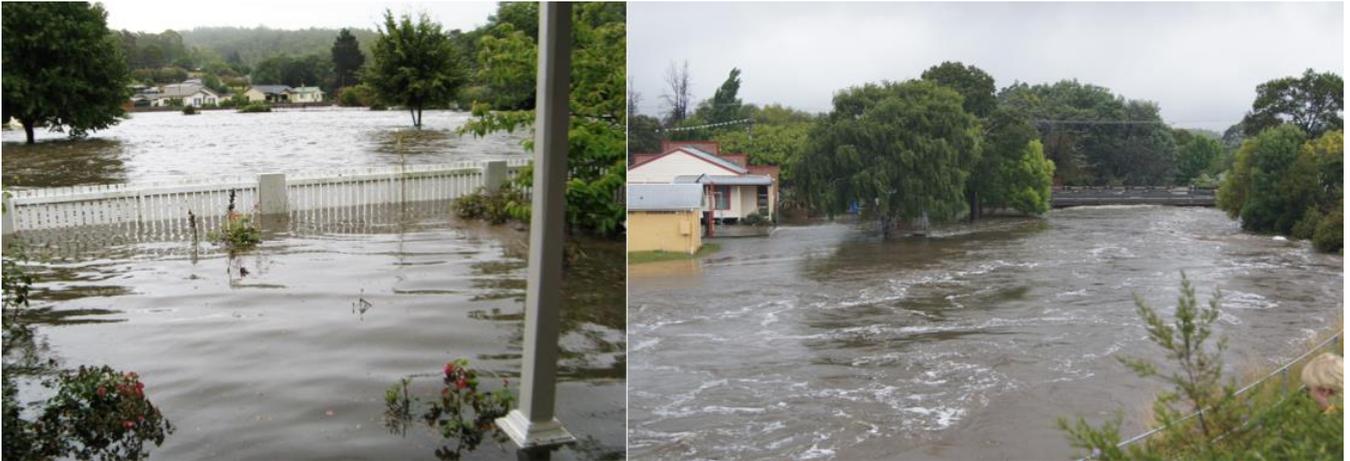
**Figure 1. Central St Marys during the January 2016 Flood Event**

2016 was a wet year across Tasmania with numerous large rainfall and flood events occurring across the state. Three significant flood events occurred at St Marys with the January 2016 event being the largest. The January 2016 flood event was a result of several wet days and then an extreme burst of rainfall in the early hours of 29<sup>th</sup> January which has been determined as approximately a 0.2% AEP rainfall event. The resulting flood event resulted in considerable damage to the town, including above floor flooding at several properties.

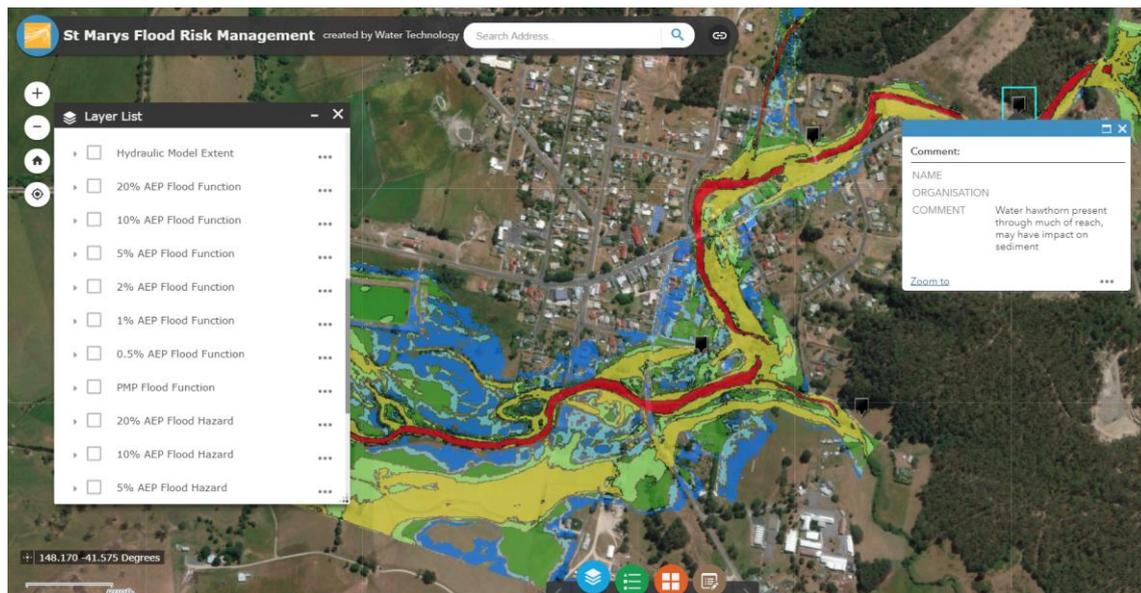
Figure 3. Screenshot from the St Marys Online Mapping Portal

In addition to the consultation described above, the community engagement process was enhanced through the development of an online flood study portal (Figure 3). The portal allowed key outputs of the study to be shared through a “Google Maps” type environment and allowed community members to leave comments and feedback on the findings as well as submit ideas around flood management and mitigation ideas.

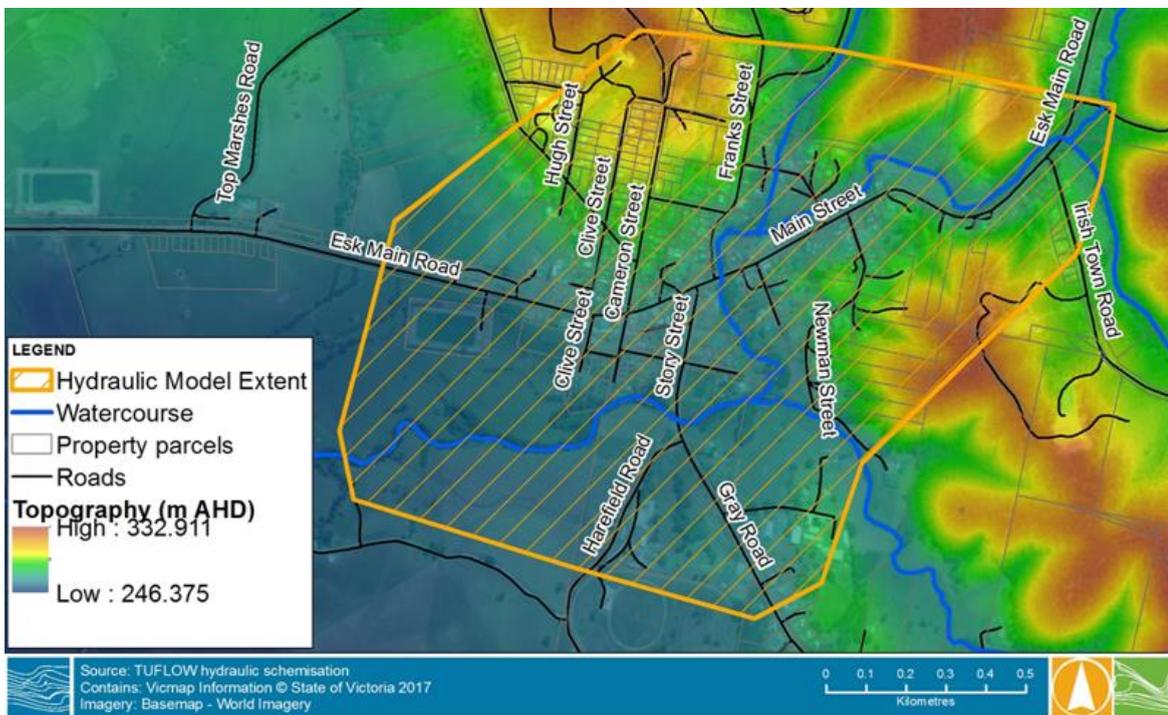
Figure 4. Hydraulic model extent and model DEM (Digital Elevation Model)

Detailed hydrological and hydraulic modelling was undertaken for the project, which was undertaken in line with Australian Rainfall and Runoff 2016. Hydrologic modelling was completed in RORB, while the hydraulic modelling utilised TUFLOW. RORB is an industry standard rainfall and runoff modelling package used widely throughout Australia and was used to determine flows into St Marys, TUFLOW is also widely used and a benchmarked 1D and 2D hydraulic modelling package. TUFLOW was used to determine flood levels, depths and velocities across the township. The hydraulic model extent and DEM (digital elevation model) is shown in Figure 4.

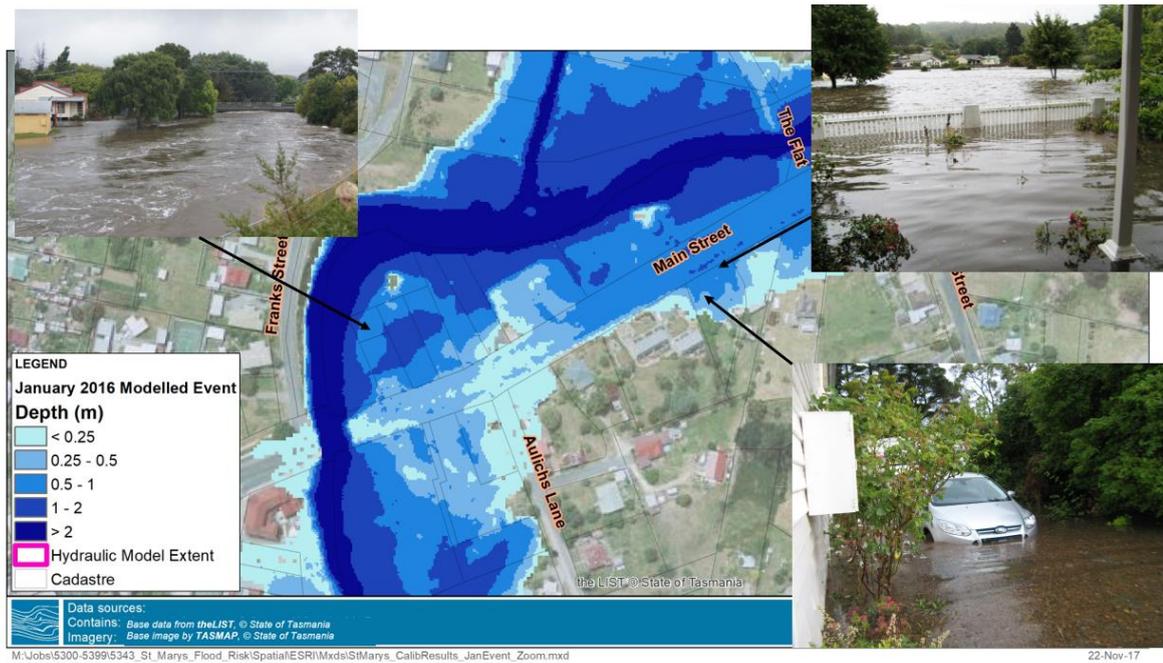
Figure 5. Validating the hydraulic model results to flood photos of the January 2016 event

The hydrologic and hydraulic modelling components were completed in tandem due to the available streamflow and rainfall data being limited and of poor quality. Whilst there was limited recorded streamflow or water level data to calibrate the model, there was significant amounts of anecdotal information and flood photos of the three flood events which occurred in 2016. This information was used to validate the results in the hydraulic model and to inform the hydrologic modelling. This tandem approach is commonly used on ungauged catchments and aims to reduce uncertainty as much as is practical in the modelling results. An example of the model validation for the January 2016 event is shown in Figure 5.

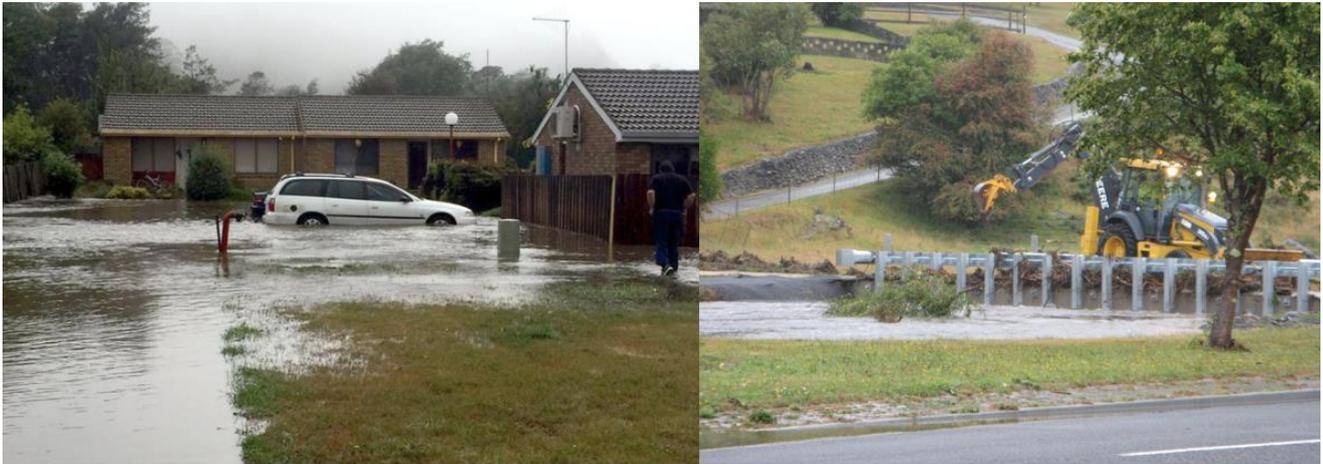
**Figure 6. Some of the focal areas of recommended mitigation works - breakouts near Groom Street (left) and flood debris on The Flat bridge (right) during the January 2016 event**

- A low-level levee or bund at the rear of Groom Street, which is the location of a significant breakout during the January 2016 event that inundated several units. The modelling has shown that a well-designed levee or bund would prevent breakout occurring in smaller flood events whilst minimising any adverse impacts of the levee in large flood events.

- Replacement of The Flat road bridge over St Marys Rivulet with a ford structure. The Flat Bridge is located centrally in the town and consists of a thick slab which significantly reduces the capacity of the waterway. The bridge is also noted to capture significant debris loads in large flood events.

Hydraulic modelling demonstrated a ford structure would reduce flood levels in the vicinity of the bridge including down the main street of St Marys and nearby residential properties.

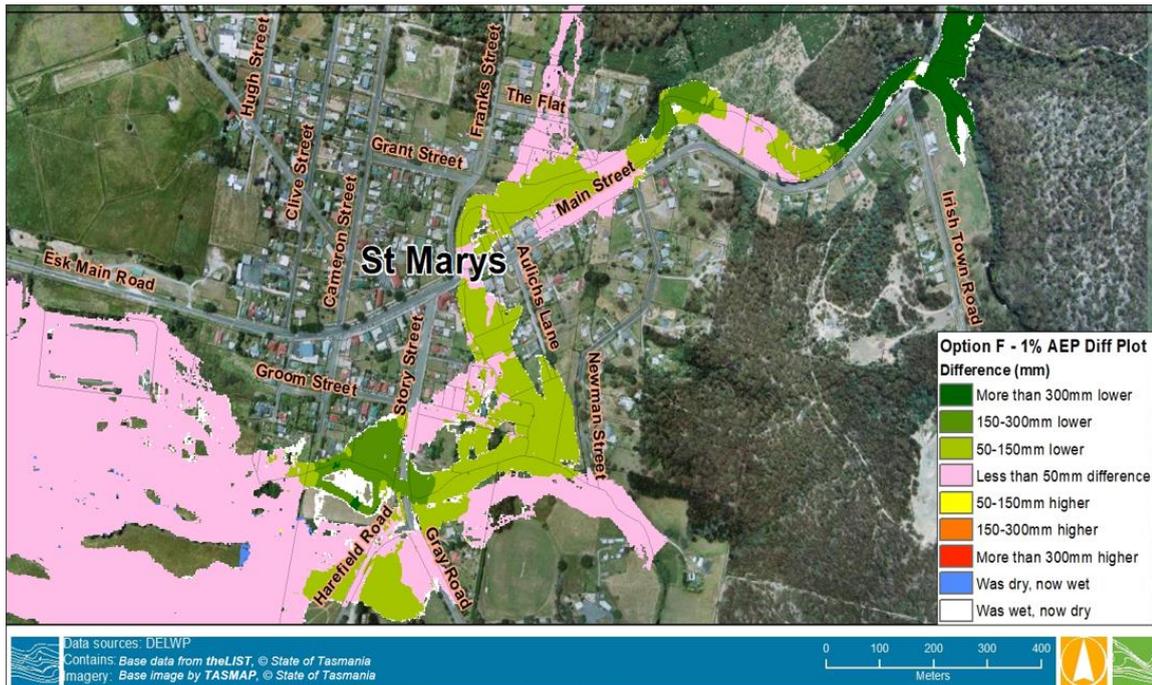
Figure 7. Impact on 1% AEP flood levels with widespread vegetation and debris removal

Several model scenarios were run with varying levels of vegetation clearing, represented by a reduction in hydraulic roughness within the channel and through riparian areas. An example of a difference plot is shown in Figure 7 which compares current 1% AEP flood levels under conditions to an extreme scenario of widespread vegetation along the full length of the rivulet through the township. The results showed that even with such dramatic vegetation works, the flood extent is largely unchanged. There are some localised reductions in flood levels, but residential areas that suffered the most damage largely do not benefit from the vegetation works. The hydraulic modelling helped the community understand the benefits that could be achieved from such works and thus helped inform their decisions around which options should be recommended as part of the plan. It also alerted them to the potential for works to produce side effects and increase inundation risks in places.
