Maribyrnong River Erosion Control Project – Floating Boom Trial

Zoe Samson¹ and Michael Bain²

1 Melbourne Water, 990 Latrobe Street Docklands VIC 3008

2 Alluvium, level 1, 105-115 Dover Street Cremorne VIC 3121

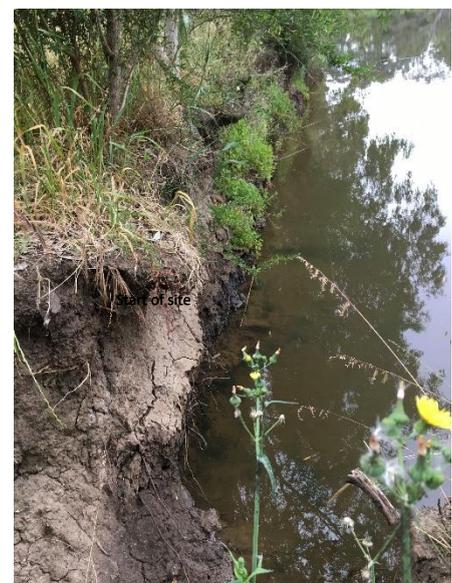
The bank is actively retreating in the study reach, with isolated pockets of retreat observed throughout the reach (refer Figure 2). Tension cracks were observed at several locations, indicating mass failure of the steep bank is a primary cause of bank erosion and retreat.

Figure 2. Example of mass failure and bank retreat at subject reach

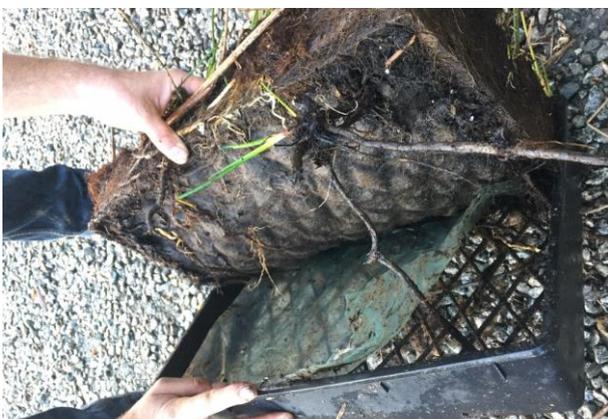
In order to prepare the plants for delivery directly to the riverbed the plants were grown as 'slabs' in plastic multipack trays (refer Figure 8 below). The aim was to have the trays filled with dense active roots that would hold together once the tray was removed at planting. Each plant slab was staked into the river bed with a single hardwood stake. A 1.5m gap was maintained between each slab to allow sufficient space for the vegetation to expand and colonise the site.

Figure 9: Multipack tray format proposed for seedlings
