NEW CONSTRUCTION OF THE "SESERAGI FISHWAY" IN MIYANAKA INTAKE DAM AND ADAPTIVE MANAGEMENT

2 DESIGNING OF FISHWAY AND METHODOLOGY

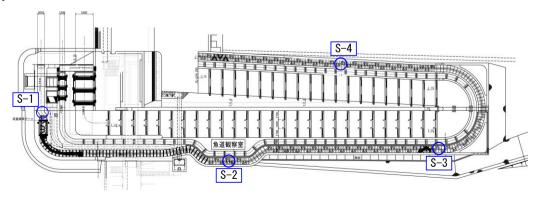
Miyanaka fishway has a half circular shape turning pool in the middle and is composed of three fishways (Fig. 1); the large sized traditional "Ice Harbor" fishway, the small sized simple ladder fishway, and natural stream style fishway, "seseragi fishway", which is a meandering channel with gravelly bed (Table 1). The fishway has the total length of approximately 209.5 m and has approximately 1/15 and 1/16.7 slope. Flow rate of each fishway is approximately 1.64 m 3 /s and 0.133 m 3 /s for the large and the small ice harbor types, respectively. The slope of "seseragi fishway" is 1/20, slightly less than others and its flow rate is approximately 0.022 m 3 /s. The fishway was re-constructed in 2012.

Figure 1. The plan view of Miyanaka fishway.

Then, benthic algae were sampled from a 5 cm x 5 cm quadrat on the surface of boulders at four sites along the fishway (Fig. 1).

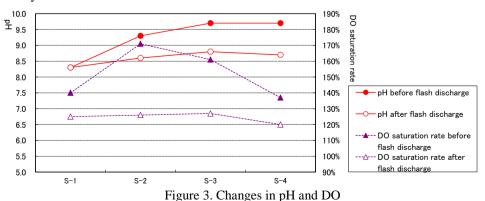
PH of water rose from the upstream to the downstream by one unit before the flushing and 0.5 unit after the flushing, respectively (Fig. 3). This indicates that although the photosynthesis was conducted by benthic

algae as to increase pH in the fishway significantly both before and after the flushing, the rate significantly decreased due to the reduction of benthic algae by flushing. Before the flushing, DO of water markedly increase from S-1 to S-2, while it declined in the downstream. The reduction is due to the shading by the side wall in the downstream half of the fishway. After the flushing, on the other hand, DO was maintained constant through the fishway. Clear decline before and after the flushing indicates the reduction of the photosynthesis rate by the flushing.

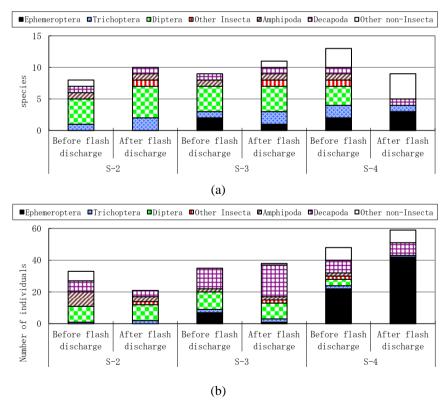
After the flushing, the species richness increased slightly in the upstream part of the fishway at S-2 and S-3, while declined in the downstream at S-4 (Fig. 5a). Species composition did not change significantly. The number of individuals declined significantly in the upstream by the flushing, while increased in the downstream reach (Fig. 5b). Ephemeroptera were mainly flushed downstream. However, unidentified species after the flushing were identified 1-2 individual before the flushing. So the flushing did not have much impact on the benthic fauna both in species composition and the numbers of individuals.

Figure 5. Changes in the composition of benthic fauna
