# Environmental Response of Reconnecting Billabongs along the Yarra River

Sarah Heard<sup>1</sup>, Simon Treadwell<sup>2</sup>, Sarah Gaskill<sup>3</sup>

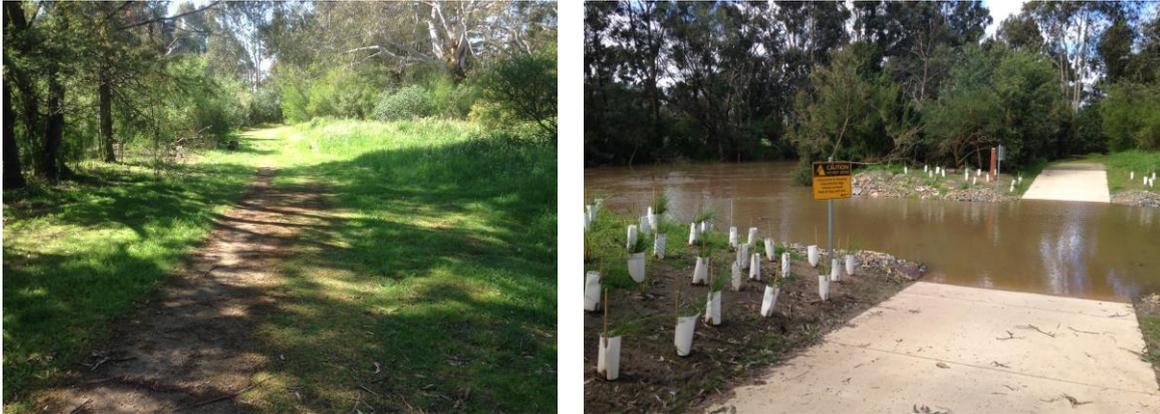
**Figure 1. Spadoni's Reserve Billabong – Left: inlet prior to works. Right: works undertaken to lower the inlet level and the lowered inlet in operation.**

In April 2016, Melbourne Water undertook the works to lower the inlet channel at Spadoni's Billabong. The lowered inlet channel is a grassed channel (up to 20 m wide), with rock embankments at the inlet and a low bank slope to facilitate foot traffic and vehicle access (Figure 1). Revegetation works were also undertaken at the inlet to help promote restoration of aquatic vegetation at the site.

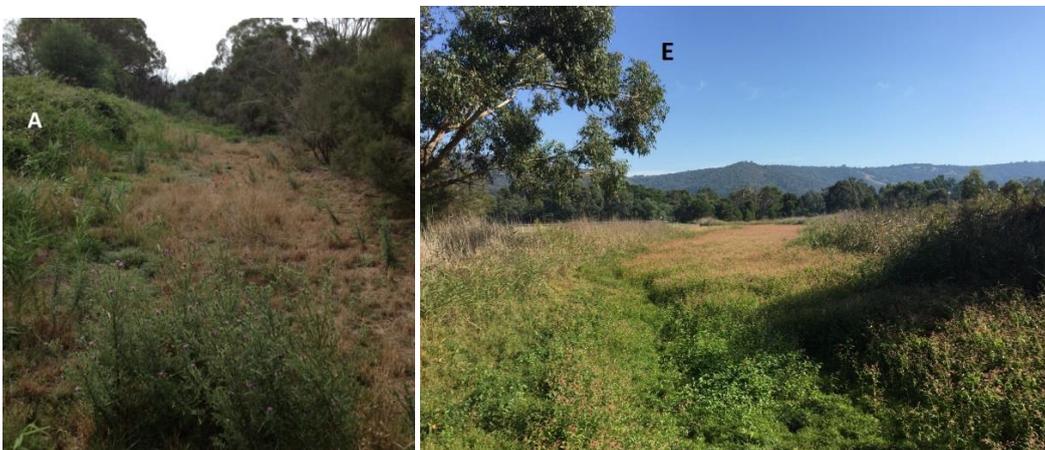
**Figure 2. Spadoni's Reserve Billabong – vegetation response over time. A - January 2015 pre works,**

### dominated by exotic species. E - April 2017 post works, increase in native vegetation

Monitoring of the vegetation within Spadoni's Billabong has been undertaken yearly since the completion of works and has shown that the vegetation cover has greatly improved as a result of the inundation, changing from a predominantly non-native vegetation community to a predominantly native Aquatic Herbland community dominated by Slender Knotweed (*Persicaria decipiens*) and Lesser Joyweed (*Alternanthera denticulate*), and the exclusion of weeds such as Drain Sedge and Toowoomba Canary Grass, that were noted prior to the works being undertaken (Figure 2). The extent and condition of this community is likely to increase overtime with more inundation events. Common Reed on the boundaries of the billabong may creep into the Aquatic Herbland community in drier periods, but is expected to recede with frequent or prolonged inundation to maintain the boundary between the herbland and fringing swamp and floodplain communities.

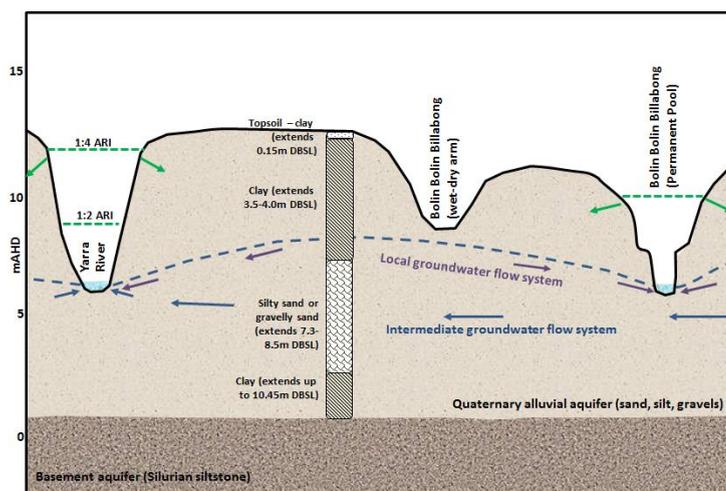
Figure 3. Conceptual diagram of Bolin Bolin Billabong including stratigraphy.

Stage 1 and Stage 2 of the framework were undertaken for Bolin Bolin Billabong and a number of uncertainties were identified including the stratigraphy of floodplain (i.e. varying gravel, sand, clay layers), seepage rates and billabong volume and how these may influence the delivery of an environmental watering solution at the billabong. If the source of the water that maintains the permanent pool is sub-surface flow from the Yarra River through the sand/ gravel lens beneath the billabong (Figure 3), there is potential that any environmental water delivered to the permanent pool may drain to the Yarra River through the lens (when the river height is below the water level in the pool). This sub-surface connection to the Yarra River would not have been an issue prior to the regulation of the river as the river water level was higher and therefore the river height would have always been above water level in the pool.

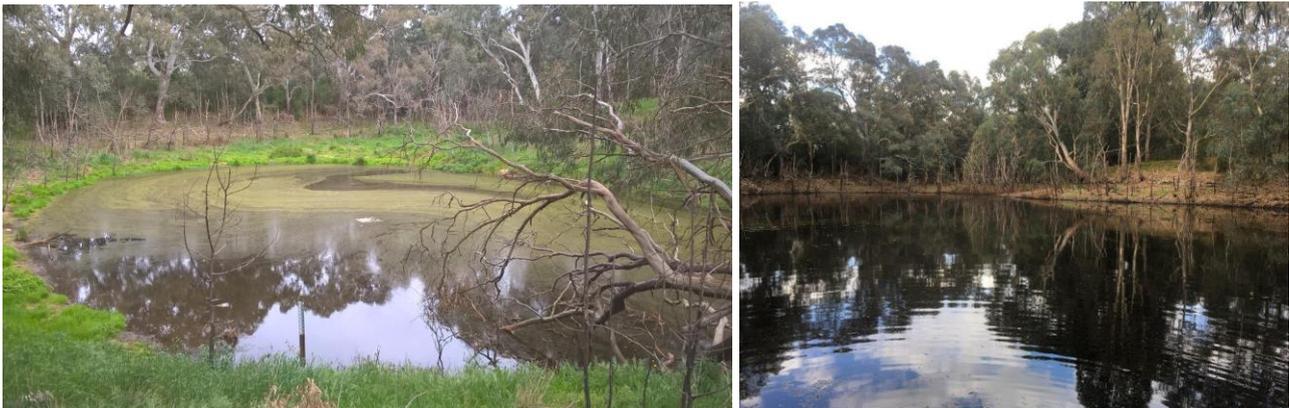
**Figure 4 Bolin Bolin Billabong pre and post environmental watering event (November, 2017). Left – permanent pool prior to watering. Right – permanent pool post watering.**

In October 2017, Melbourne Water undertook a trial watering event to investigate the uncertainty around the billabong substrate and seepage rates and to inform the development of a water regime delivery design (Stage 3 of framework). Water was pumped directly from the Yarra River at the natural inlet on the southern arm using around 70 ML of water from the Yarra's Environmental Entitlement. Monitoring was undertaken pre, during and post the watering event to monitor water levels and vegetation response in the billabong. Monitoring included vegetation assessment before and after, photopoints before, during and after, surface water and groundwater level monitoring and time lapse photography (Jacobs, 2018).

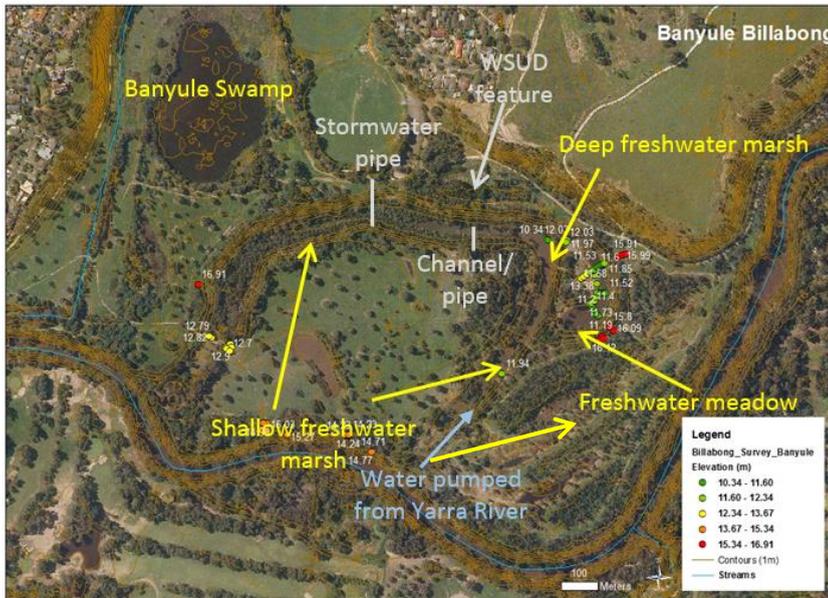
Figure 5. Banyule billabong zones – freshwater meadow and deep and shallow freshwater marsh

Banyule Billabong sits within the Yarra Valley Parklands at Banyule Flats, Heidelberg and is recognised as a priority area for fish, vegetation, frog and social values in Melbourne Water's Health Waterways Strategy. The billabong has a number of distinct zones (Figure 5). The main billabong (9.2 Ha) is comprised of two

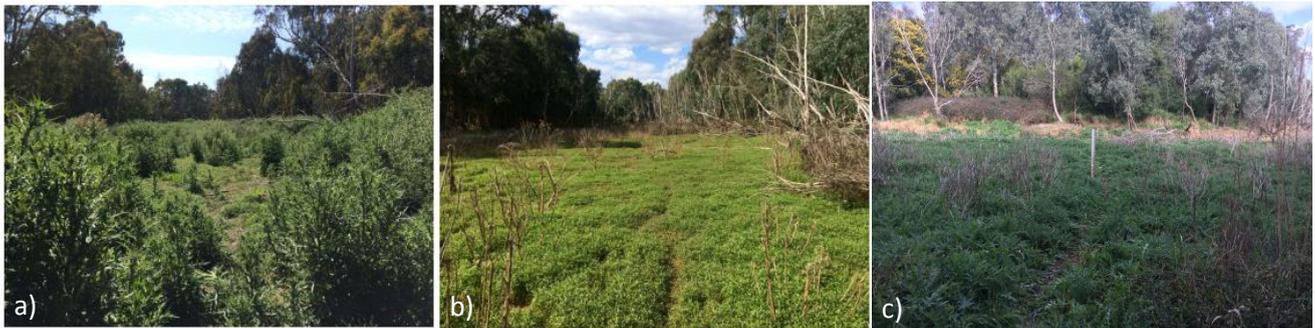
**Figure 6. Banyule Billabong Permanent photo monitoring points. a) November 2016 looking east, b) April 2017 looking east (Melbourne Water, 2017), c) September 2017 looking north.**

Prior to watering (December 2016), vegetation across the bed of the billabong was dominated by weeds, including Fat Hen (*Chenopodium album*) and Spear thistle (*Circaea vulgare*): 70-75% of the bed was covered by Spear Thistle (Melbourne Water, 2017, Figure 6a). Native species present prior to watering included Shrub Nettle (*Urtica incisa*), Lesser Joyweed (*Alternanthera denticulate*), Tall Sedge (*Carex appressa*) and Pale Rush (*Juncus pallidus*). Post watering (April 2017), the native Knot Weed, (*Persicaria* sp.) became dominant with overall weed coverage reduced to <1% cover (Figure 6b). However, more recent observations December 2017 (Figure 6c) show that the weed coverage has returned to a level comparable to that observed prior to the watering. A key learning for the delivery of environmental water for these sites is that a follow up inundation event or targeted weed control after watering may be required to prevent recolonisation by weeds. Similar to Spadoni’s Billabong, other ecological responses observed by Melbourne Water and community members as a result of the trial watering included an increase in frogs and birdlife at the billabong.

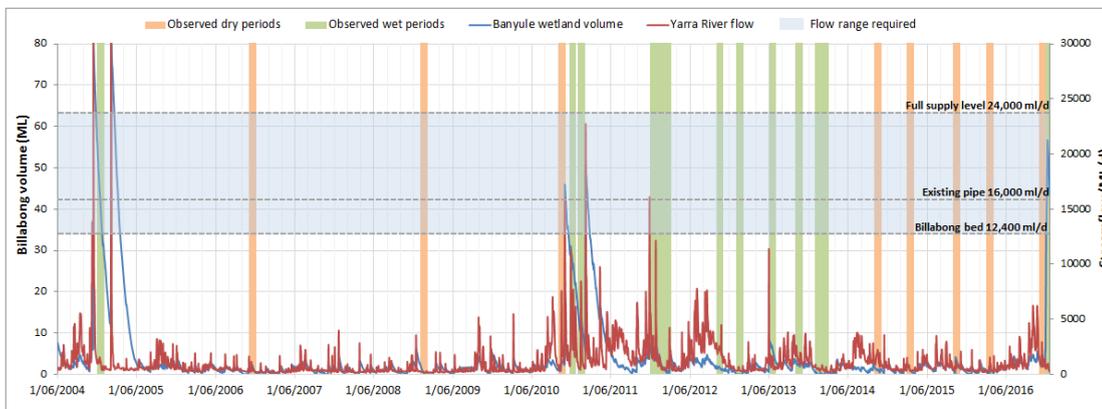
**Figure 7. Banyule billabong – modelled volume of water in the billabong (blue line), Yarra River streamflow (red line), and aerial imagery and historical observations showing wet or dry conditions (orange and green shading).**

Under current conditions, water commences to enter the billabong through a pipe buried in the river bank when flow in the Yarra River reaches 16,000 ML/d (11.4 m AHD). Overbank flow then enters the billabong when flow reaches approximately 24,000 ML/d (12.2 m AHD). The deepest part of the billabong is at 11.0 m AHD (~12,400 ML/d). Hence, if the inlet to the billabong was lowered in an attempt to increase the frequency of duration of inundation the lowest that level could be is 11.0 m AHD. An analysis of the flow regime in the Yarra River suggests that flow in this range (12,400 ML/d to 24,000 ML/d) is significantly higher than is currently experienced in the Yarra River and therefore there is limited opportunity to lower the inlet to the billabong to increase the frequency of inundation (Figure 7).
