## It's a good news story! Tracking geomorphic recovery of rivers in eastern New South Wales as part of process-based river management

Kirstie A Fryirs<sup>1\*</sup>, Gary J Brierley<sup>2</sup>, Fergus Hancock<sup>3</sup>, Tim J Cohen<sup>4,5</sup>, Andrew P Brooks<sup>6</sup>, Ivars Reinfelds<sup>7</sup>, Nick Cook<sup>3</sup>, Allan Raine<sup>3</sup>

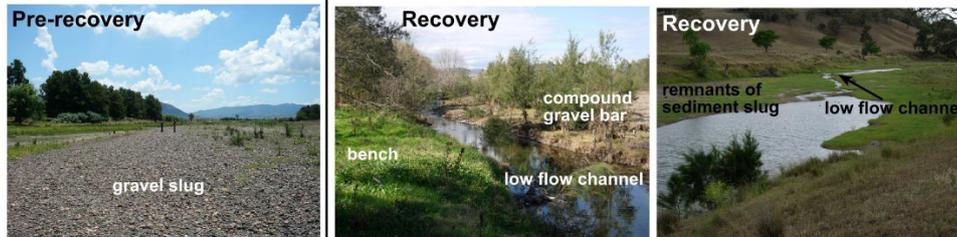
(b) distinct, well defined low flow channel (gravel bed, sediment slug affected reach)

**Figure 1** Some forms of geomorphic river recovery. (a) Left: Hunter River at Dartmouth in 1959; Source: DPI Water archive; Right: Macdonald River, NSW; Source: K. Fryirs; (b) Left: Pages River, NSW; Source: K. Fryirs; Centre: Upper Hunter River at Key's Bridge, NSW; Source: K. Fryirs; Right: Pages River, NSW; Source: K. Fryirs; (c) Left: Mulloon Creek, NSW; Source: K. Fryirs; Centre: Mulloon Creek, NSW; Source: K. Fryirs; Right: Upper Hunter River, NSW; Source: Fergus Hancock; (d) Left: Hunter River at Bureen in 1976; Source: DPI Water archive; Right: Wollombi Brook at Warkworth, NSW; Source: Nick Cook; (e) Left: Bega River, NSW; Source: Andrew Brooks; Right: Bega River, NSW; Source: Google Earth™; (f) Left: Wolumla Creek, NSW; Source: K. Fryirs; Centre: Wolumla Creek, NSW; Source: K. Fryirs; Right: Reedy Creek, NSW; Source: K. Fryirs. For a full version, see Fryirs et al. (2018).

Formation of benches via sediment deposition along channel margins and flow separation zones reduces the capacity of enlarged (incised and widened) channels, indicating that channel contraction is underway (**Figure 1a**). Multiple forms of recovery in highly disturbed macrochannel systems include the deposition and storage of sediment in compound bank-attached bars and benches (**Figure 1a**). These features provide bank toe protection for previously over-steepened banks that were prone to mass failure. The re-definition of a distinct low flow channel is an important form of recovery in instances where the bed has been highly disturbed (e.g. via incision, over-widening, sediment smothering/slug formation) (**Figure 1b**). Distinct low flow channels tend to have lower width-depth ratios than their indistinct counterparts. This form of recovery is often accompanied by the return of features such as pool-riffle sequences in active meandering rivers (**Figure 1c**) or the re-emergence of pools in bedrock reaches. The appearance of well-vegetated and stable bars and islands increases bed heterogeneity relative to the planar bed conditions of some pre-recovery systems (**Figure 1d**). Along macrochannel reaches that have experienced significant over-widening and an oversupply of sediment, the reorganisation and selective transfer of sediment, and the stabilisation of bars and islands, produces a multi-channel low flow network in a formerly sediment slug affected reach (**Figure 1e**). Elsewhere, for quite different types of river, re-formation of swampy (wetland) conditions on the bed of an incised channel within valley fill deposits marks recovery to a discontinuous watercourse (**Figure 1f**).

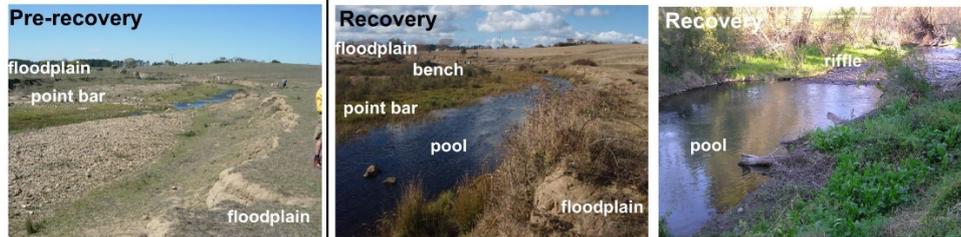
(c) reemergence of alluvial pools and riffles within low flow channel (meandering reach)

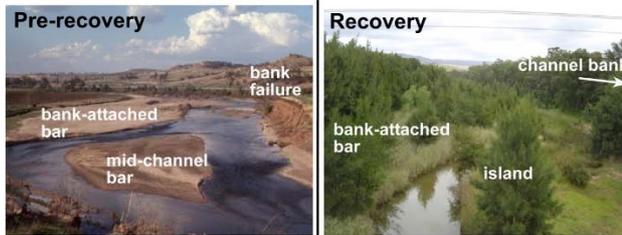
(d) well vegetated, stable bars and islands

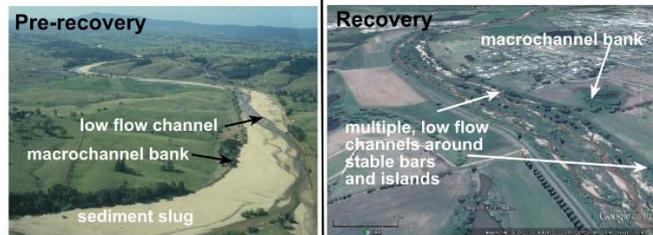
(e) low flow channel multiplicity
